Figure 5. Residual PCB Contamination, GTSP/NBF Fenceline

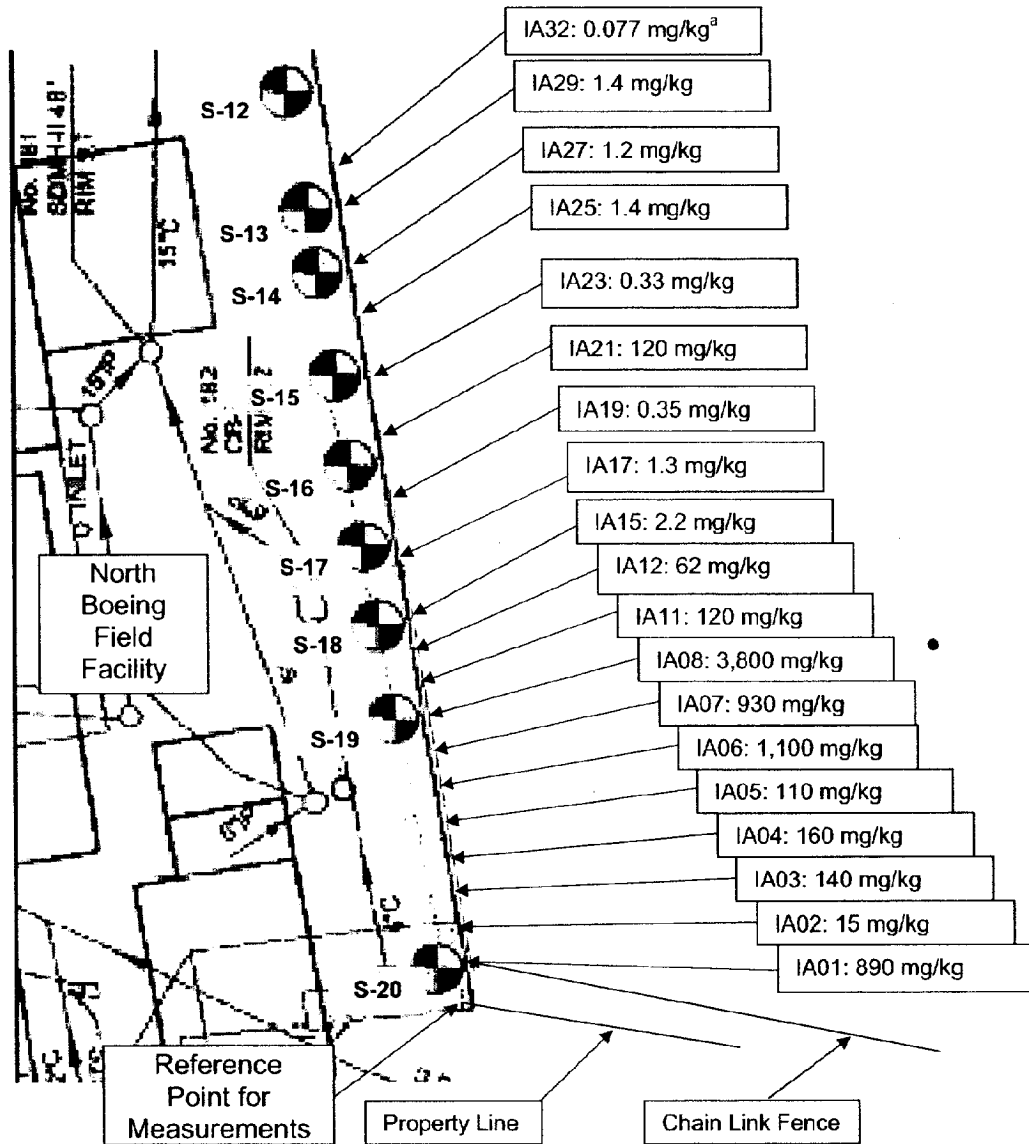
The PCB concentrations noted below are from samples collected at approximately 1.5 m intervals at the base of the interim action excavation. These results will be considered in developing the upcoming site-wide investigation plan. For reference, Sample Stations S-12 through S-20 indicate positions of previous soil sampling.

^aResult includes sum of Aroclors 1254 and 1260. For all other samples, only Aroclor 1254 was detected.
